# **NATIONAL TRANSPORTATION SAFETY BOARD**

## **AIRCRAFT ACCIDENT REPORT**

**FISCHER BROS. AVIATION, INC.,  
dba NORTHWEST AIRLINK, FLIGHT 2268  
CONSTRUCCIONES AERONAUTICAS, S.A. (CASA)  
C-212-CC, N160FB  
DETROIT METROPOLITAN WAYNE COUNTY AIRPORT  
ROMULUS, MICHIGAN  
MARCH 4, 1987**

**NTSB/AAR-88/08**

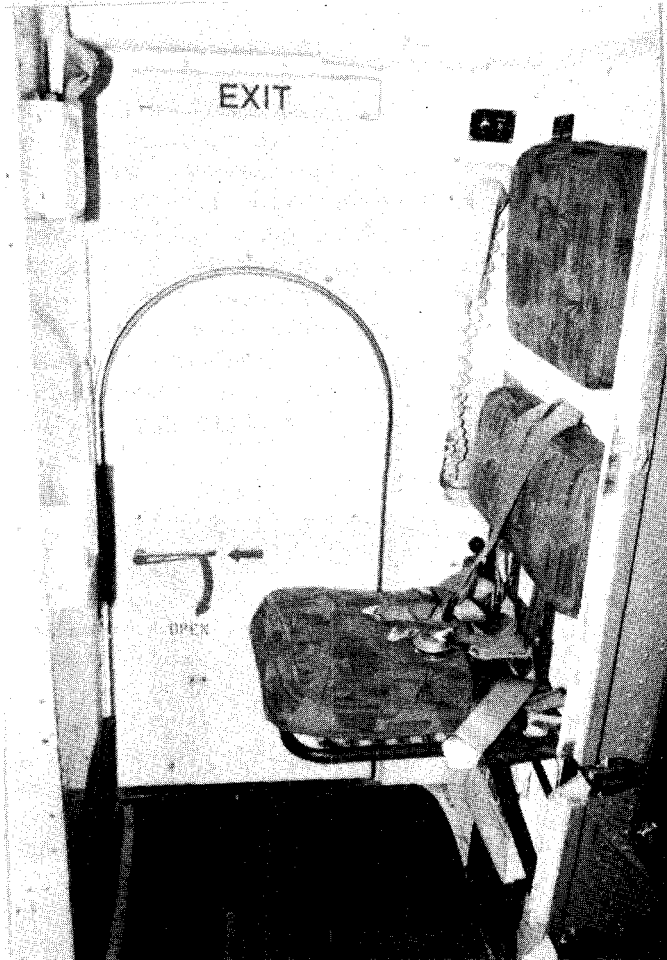
The flight attendant's retractable seat was installed on the left side of the forward cabin bulkhead, adjacent to the left forward Type II emergency exit. (See figure 3.) In the extended position, the seat blocked passage to the exit. The seat was found retracted, but it was not equipped with an automatic folding mechanism feature. The seat was designed and certified by the airplane manufacturer, but there was no data plate visible on the seat frame. The FAA issued AD 87-05-07, effective March 25, 1987, requiring installation of an automatic retract mechanism in the seat in accordance with the manufacturer's Service Bulletin (SB) 212-25-32 of October 23, 1985.

Figure 3.--Flight attendant's seat adjacent to the left forward exit taken from a similarly-equipped CASA-212.

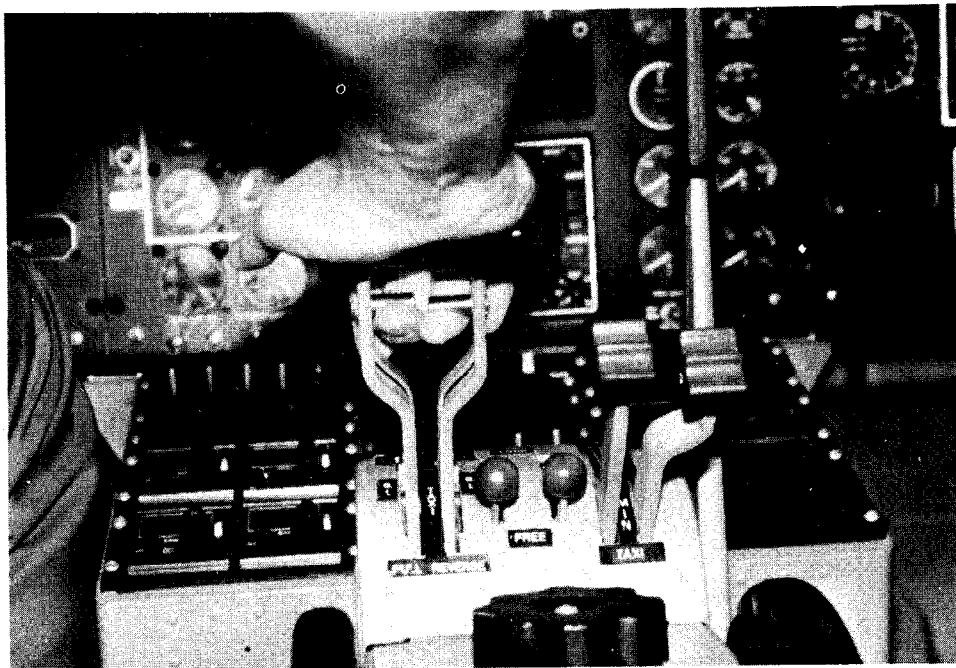
- With the right hand placed with the palm on top of the PL knobs, the fingers can easily touch the beta latch arm (flight idle latch arm) without moving the hand and could be done unconsciously. (See figures 9, 10, and 11.)

Figure 10.--Closeup of the PLs showing operation of the latch lever arms with the PLs in the full reverse position.
