ÉTUDE DE CAS

CASA C-212 Aviocar 200

NTSB/AAR-88/08

1. Report No. NTSB/AAR-88/08		2. Government Accession No. PB88-910410		3. Recipient's Catalog No. [REDACTED] [REDACTED]	
4. Title and Subtitle Aircraft Accident Report--Fischer Bros. Aviation, Inc., dba Northwest Airlink, Flight 2263 Construcciones Aeronauticas, S.A. (CASA) C-212-CC, N160FB, Detroit Metropolitan Wayne County Airport, Romulus, Michigan, March 4, 1987				5. Report Date September 14, 1987

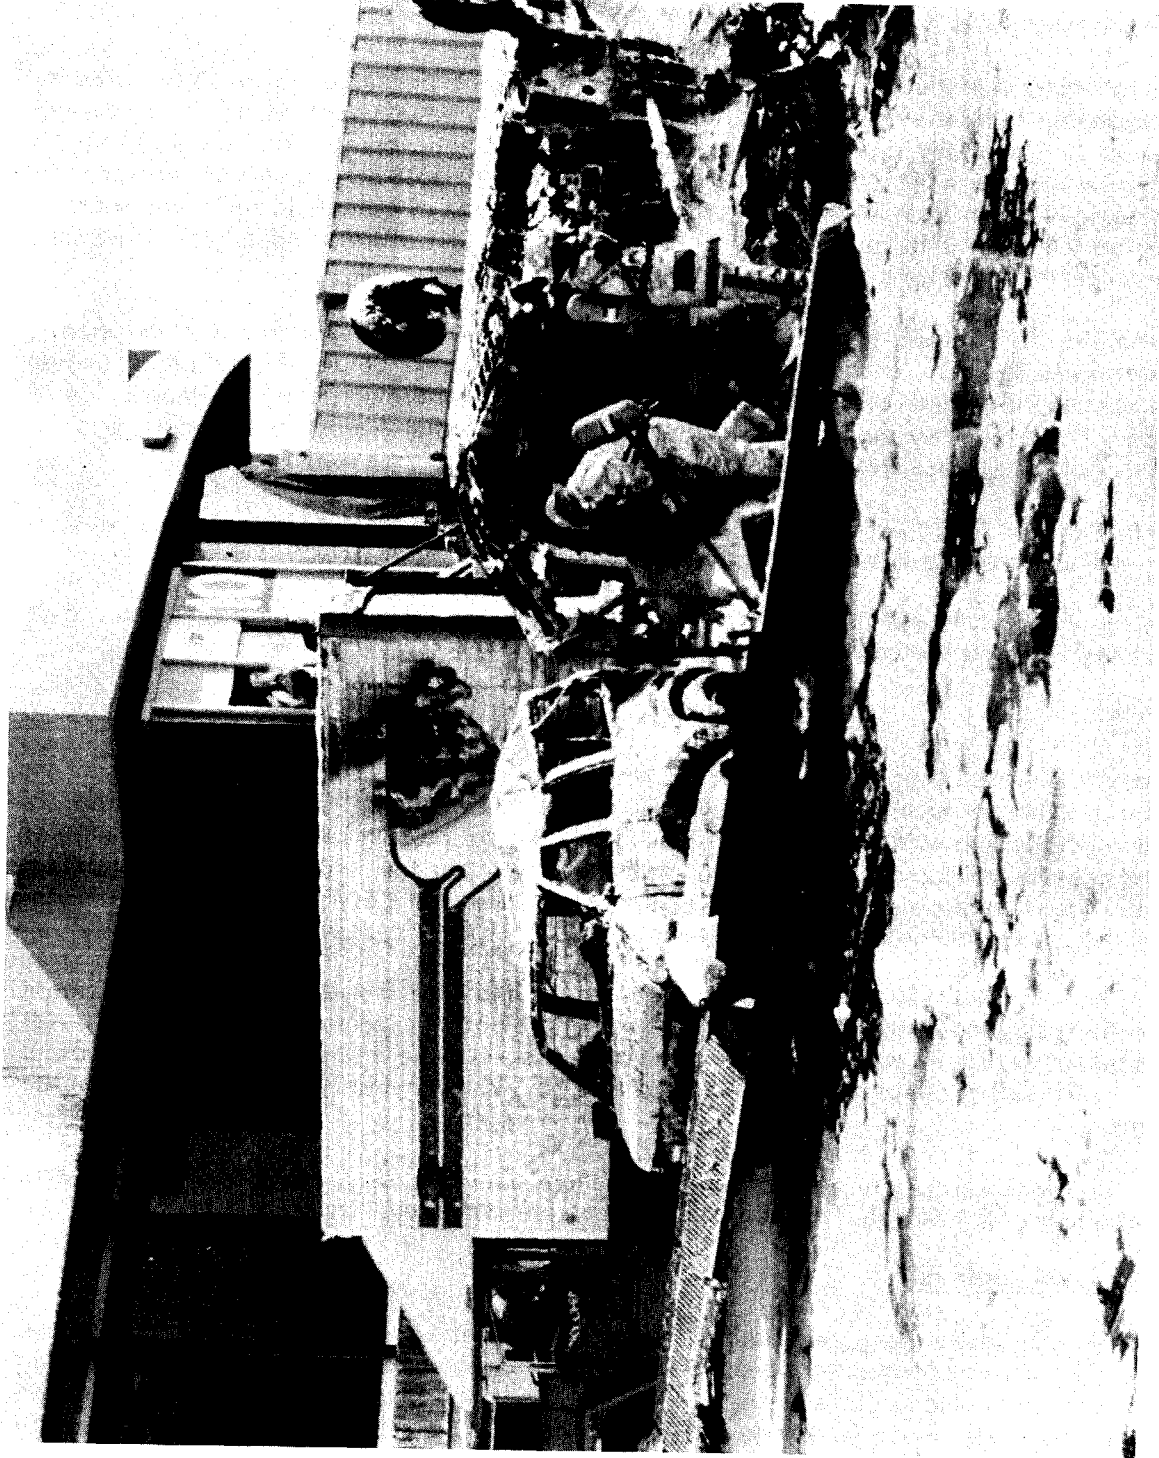
Figure 1.--Crash scene in front of Concourse F, Gate 0.

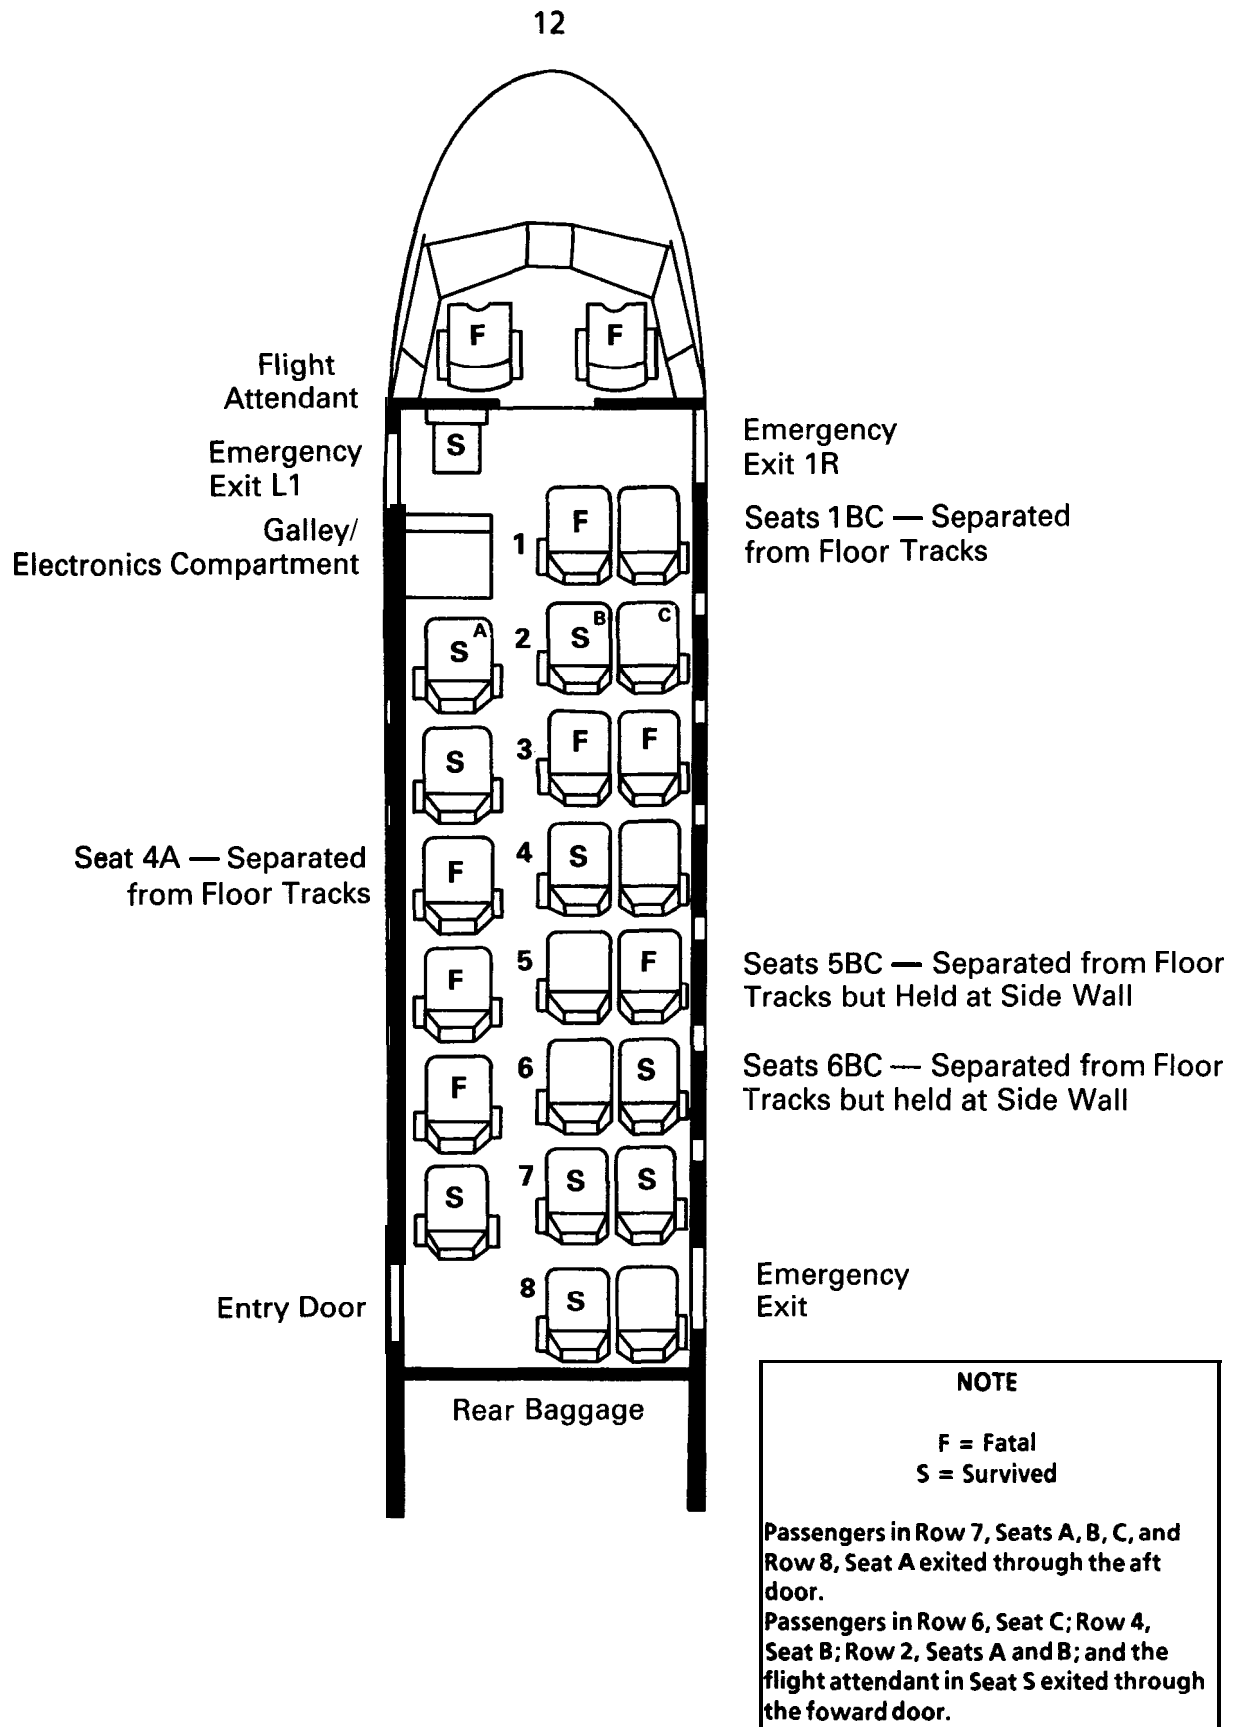
Figure 2.--Fischer Bros. CASA C-212-CC cabin seat configuration.

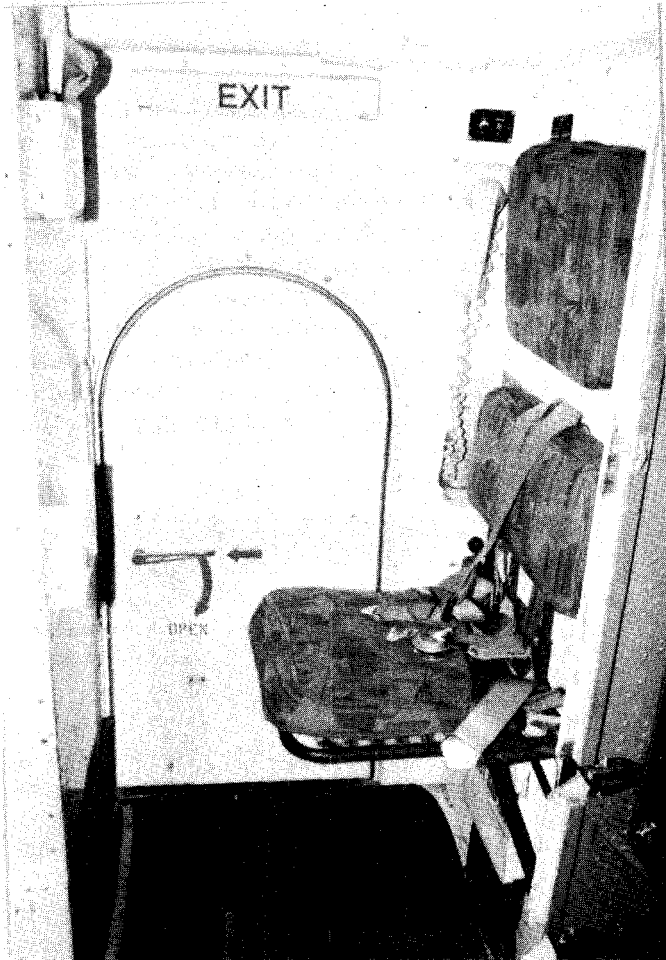
The flight attendant's retractable seat was installed on the left side of the forward cabin bulkhead, adjacent to the left forward Type II emergency exit. (See figure 3.) In the extended position, the seat blocked passage to the exit. The seat was found retracted, but it was not equipped with an automatic folding mechanism feature. The seat was designed and certified by the airplane manufacturer, but there was no data plate visible on the seat frame. The FAA issued AD 87-05-07, effective March 25, 1987, requiring installation of an automatic retract mechanism in the seat in accordance with the manufacturer's Service Bulletin (SB) 212-25-32 of October 23, 1985.

Figure 3.--Flight attendant's seat adjacent to the left forward exit taken from a similarly-equipped CASA-212.

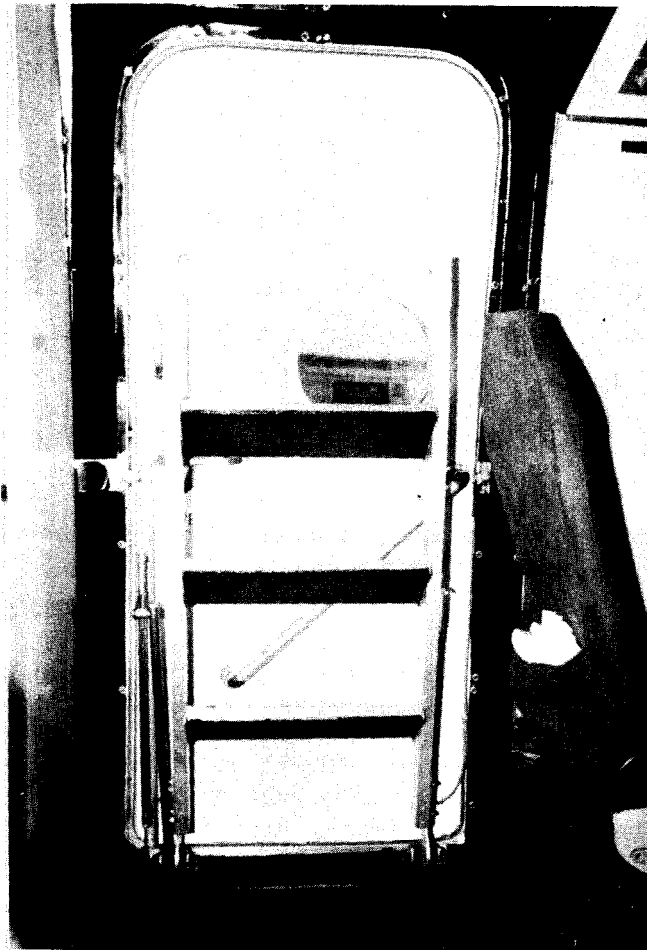
Figure 4.--Position of the folding stairs at the left main cabin entry door taken from a similarly-equipped CASA-212.

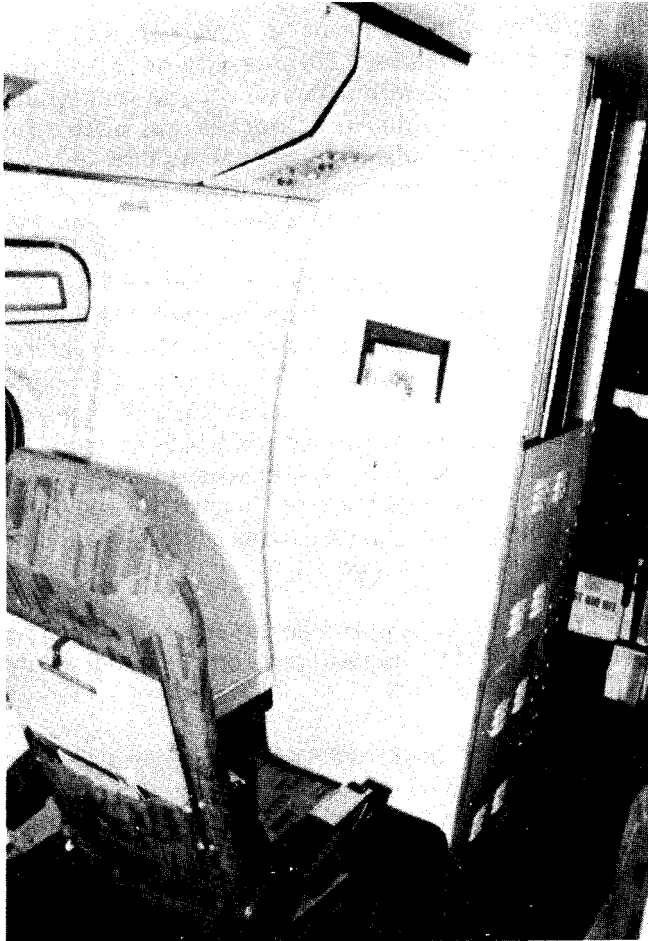
Figure S.--Rear view of seat 2-A behind the galley/electronic compartment.

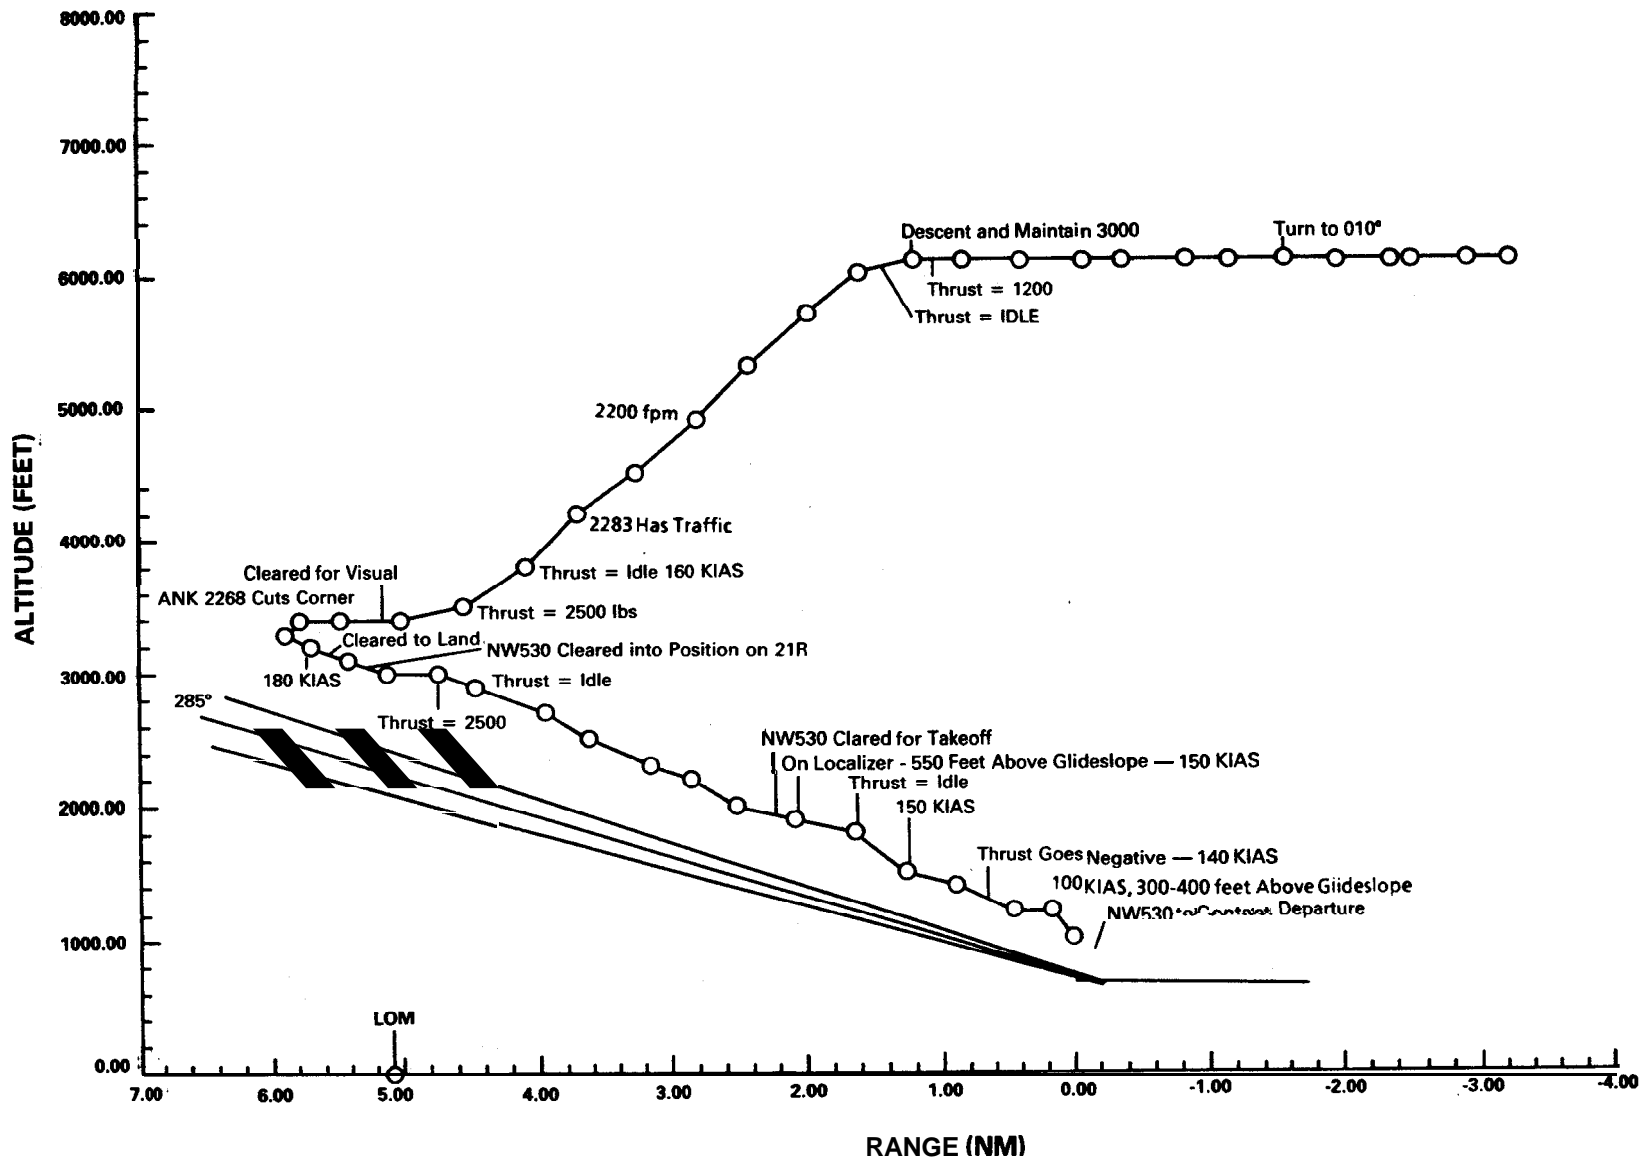
Figure 8.--Computer-generated flight profile.

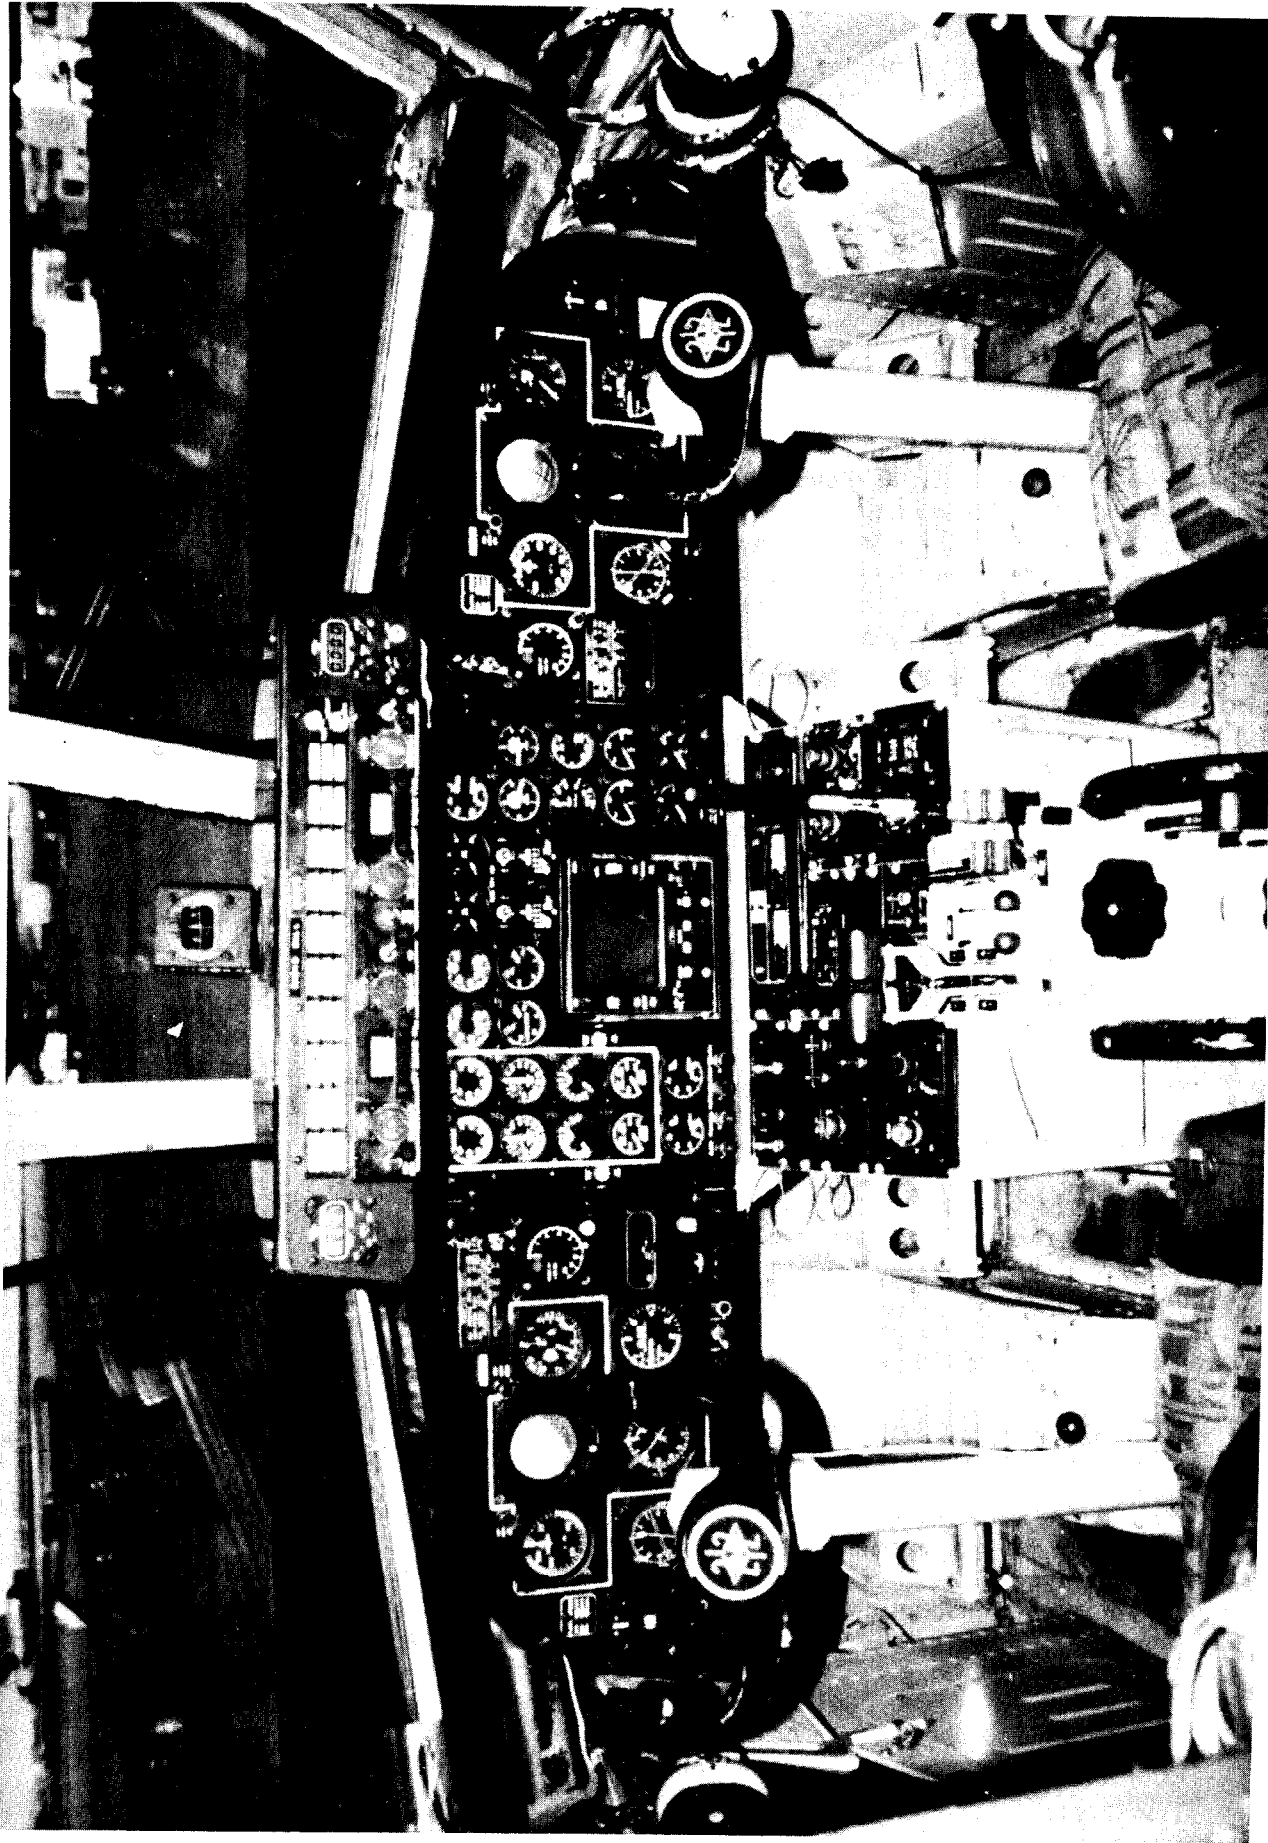
Figure 9 ---Cockpit layout of a Fischer Bros. CASA C-212-CC.

- With the right hand placed with the palm on top of the PL knobs, the fingers can easily touch the beta latch arm (flight idle latch arm) without moving the hand and could be done unconsciously. (See figures 9, 10, and 11.)

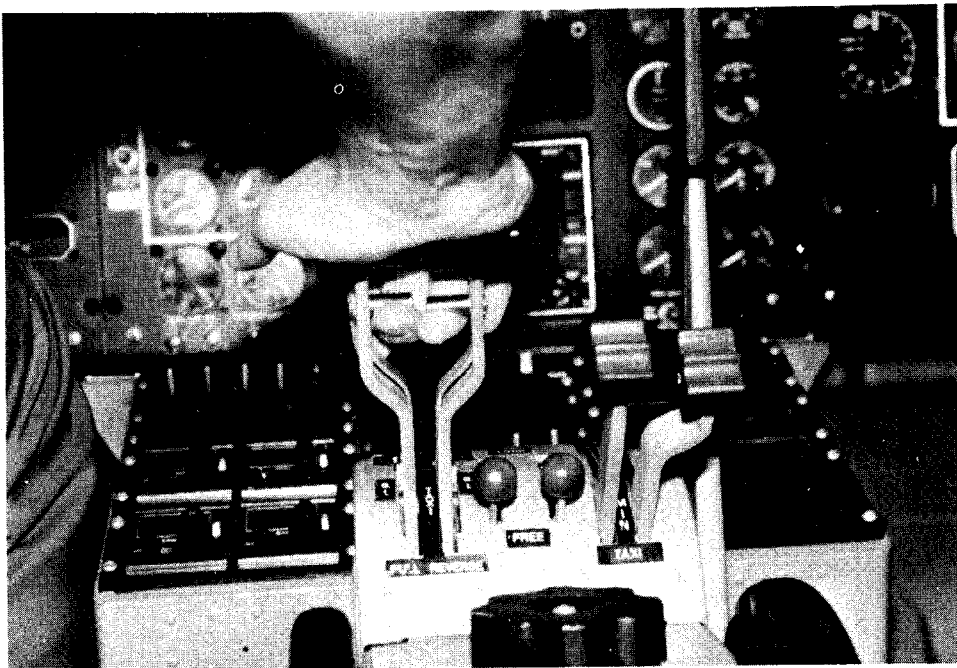
Figure 10.--Closeup of the PLs showing operation of the latch lever arms with the PLs in the full reverse position.

- The beta latch mechanism was easy to move upward, requiring only finger movement. The latch had to move 1/2 inch, from full retraction to full extension, to clear the flight idle gate. It was noted that movement of the latches was more difficult if the PLs were against the flight idle gate than if they were at an intermediate position in front of the gate. This was attributed to the resistance of the latch plate against the gate.
